Steering arms

by David Cochrane

entnommen: Magazine of The Austin Seven, Ausgabe 2004B,

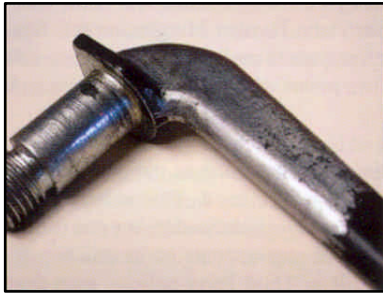
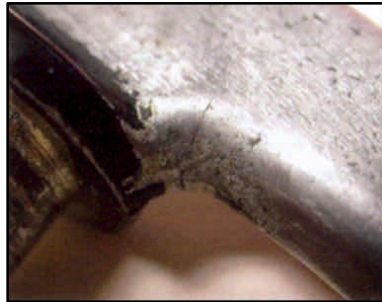
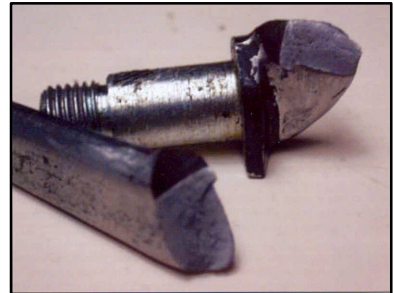
Cracked and broken steering arm (Bruce White)

several batches of steering arms which came through their hands. They managed to crack test a total of about 60 arms, and found that the average failure rate (i.e. cracks present) was around 70-80%.
